# THE SKINNER OIL RECTIFIER

## MAINTENANCE INSTRUCTIONS

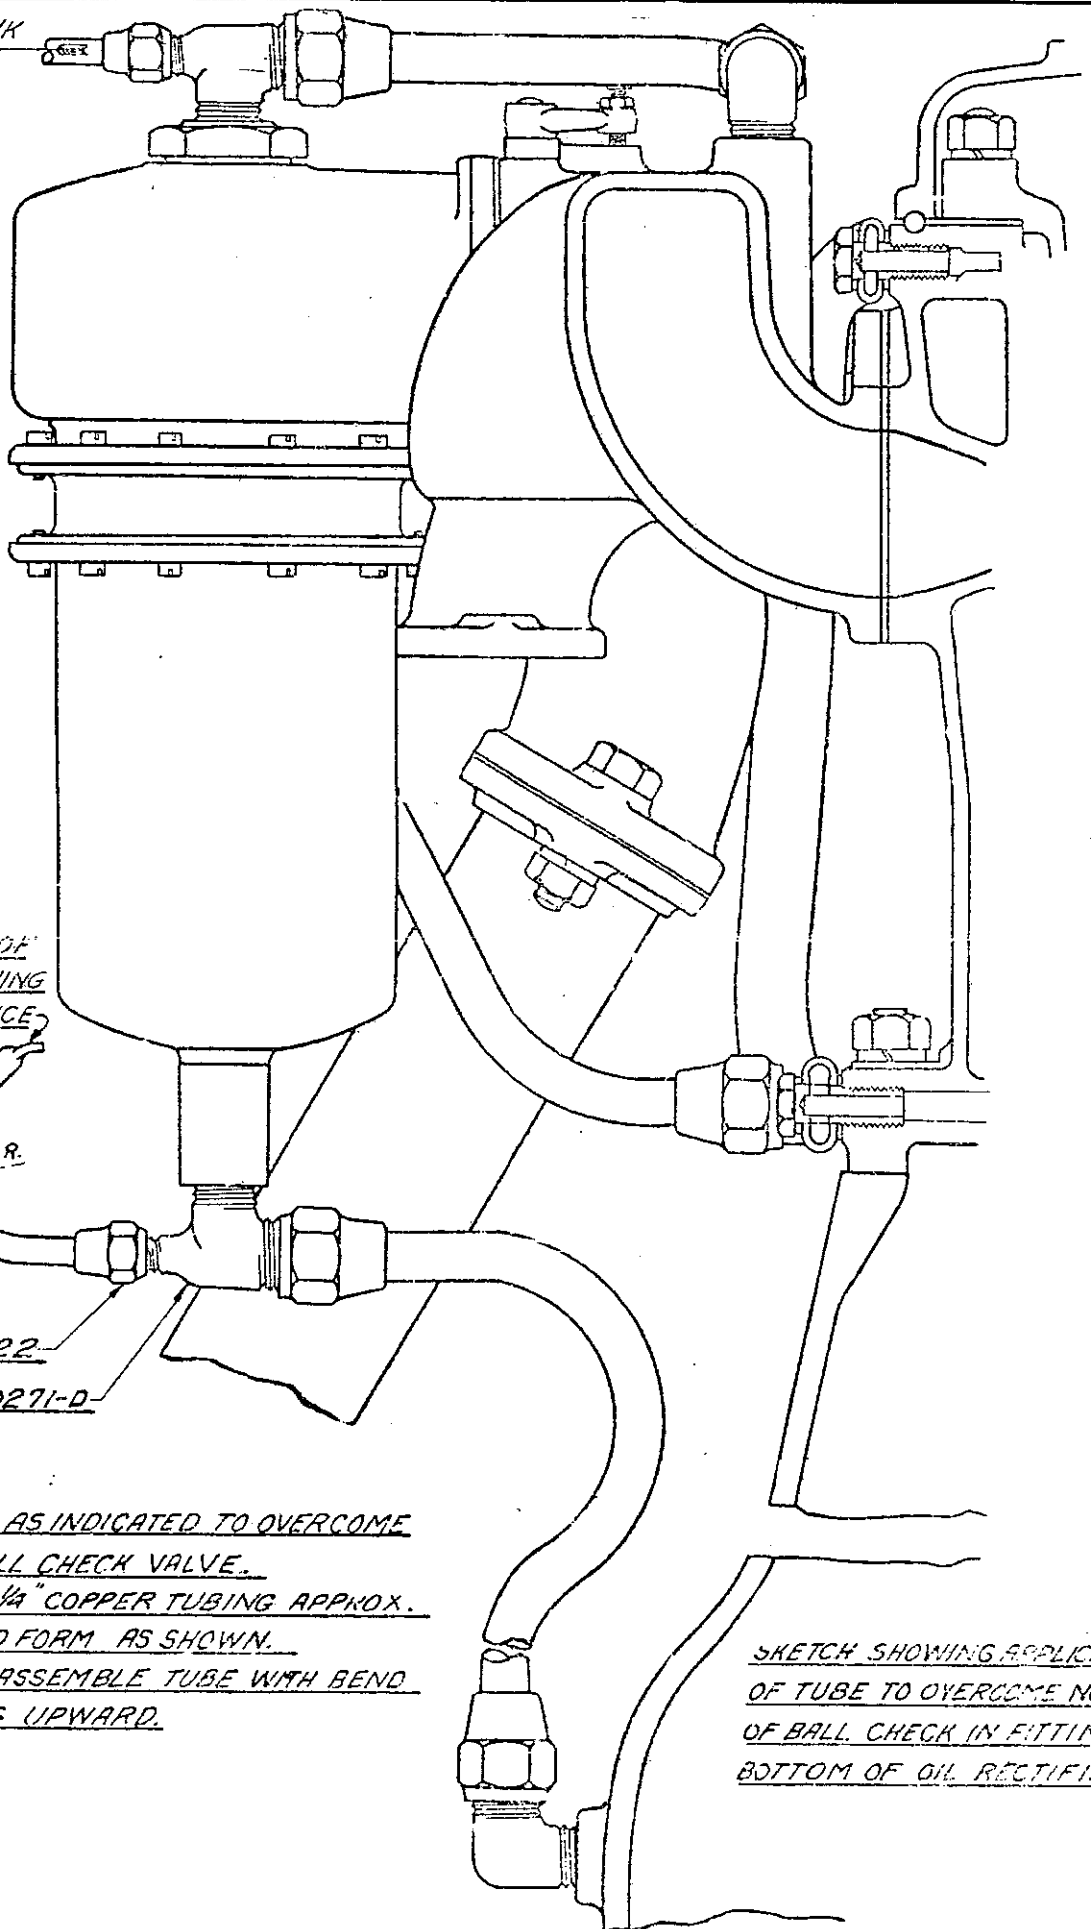
Reproduced on pages 18 and 19 are maintenance instructions issued by Willys-Overland in 1928. The sketch on page 20 is from a 1925 Willys-Overland Service Letter and shows a method of overcoming a buzzing noise in the rectifier caused by vibration of the check ball in the bottom fitting when the float mechanism trips. The ell fitting at the bottom of the rectifier should be replaced with a tee fitting and a ¼ inch copper tube as indicated. The addition of this tube forms an air cushion which prevents the check ball from vibrating.

SKETCH SHOWING APPLICATION  
OF TUBE TO OVERCOME NOISE  
OF BALL CHECK IN FITTING AT  
BOTTOM OF OIL RECTIFIER.

- APPLY TUBE AS INDICATED TO OVERCOME
- NOISE OF BALL CHECK VALVE.
- MAKE FROM  $\frac{1}{4}$ " COPPER TUBING APPROX.
- 4" LONG AND FORM AS SHOWN.
- BE SURE TO ASSEMBLE TUBE WITH BEND
- PROJECTING UPWARD.
